Damage to brick-lined culvert during flood

Case ID#

3243

# England Regulator Reference No. 502 **Legal Status** Statutory **Reservoir Type** Impounding **Reservoir Capacity** 25,000 - 99,999m3 **Year of Construction** 1850 - 1899 **Main Construction Type** Earth fill embankment **Dam Height** 5 - 9.99 metres **Dam Flood Category** В **Hazard Class** High-risk reservoir Reservoir Use Other **Owner Type**

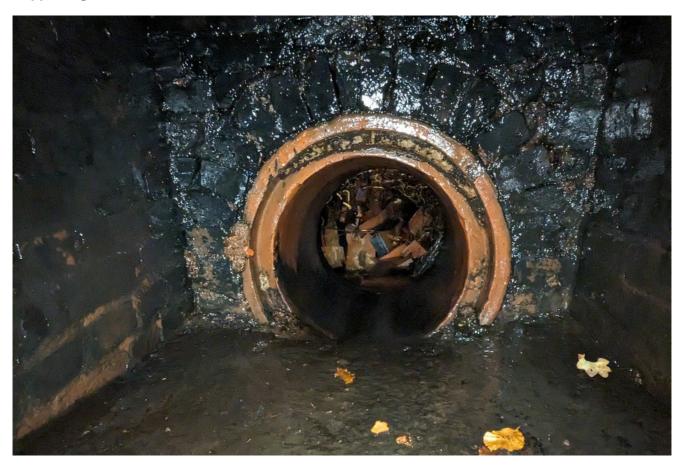
During the passage of a flood event, damage was caused to a 450mm diameter brick-lined spillway culvert under an earthfill dam embankment. A sinkhole was discovered on the line of the culvert just downstream of the downstream toe of the embankment. The available drawoff facilities are connected into this common outlet culvert that had become blocked therefore, these outlets could not be used to lower the reservoir water level. A pump was deployed to reduce the reservoir water level and the flow passing through the culvert. Fortunately, the dam did not overtop as a result of the incident. Visual inspection from a chamber immediately downstream of the damaged section of culvert found that the brick lining of the culvert had completely collapsed. Excavation revealed the presence of tree roots within the culvert. On clearing the blockage, tree roots were observed to be present in many locations through the crown of the culvert. As a temporary repair, a section of pipe was installed to act as a sleeve past the area of damage until a permanent repair or replacement pipeline can be provided.

Damage to brick-lined culvert during flood

- External erosion
- Failure or damage to tunnel or culvert
- Internal erosion (adjacent to structures)

The main lesson highlighted here would be that the age, construction and size of this culvert all played a part in its demise it would have been difficult to comprehensively assess the structure of the brickwork within the culvert along its entire length. Even if this could have been done successfully, any remedial work would have required excavation from the top down and thus cause a greater level of damage to the structure in order to repair it. This is the only remaining brick culvert within the Undertaker's dam / lake system and when a permanent repaid is complete it will likely have to be replaced in its entirety. The culvert conveyed water from two draw-off pipes and the overflow. The dam may have failed if the culvert collapsed immediately under the dam embankment. Blockage of a spillway can also lead to failure by flood overtopping. In this case, the undertaker found the damage through a routine surveillance visit. Investigations found that tree roots had penetrated the culvert which would have weakened the crown of the culvert. The incident highlights: the value of routine surveillance visits the need to periodically inspect culverts by CCTV or other appropriate means to assess structural condition one of the risks with mature trees growing on dam embankments If you need to inspect culverts or assess their structural condition it may be necessary to isolate the culvert from the reservoir. Reservoir lowering is likely to allow for this. These inspections are particularly important where pipelines or culverts pass directly under the dam.
