3249

Leakage and breach of washland flood storage embankment

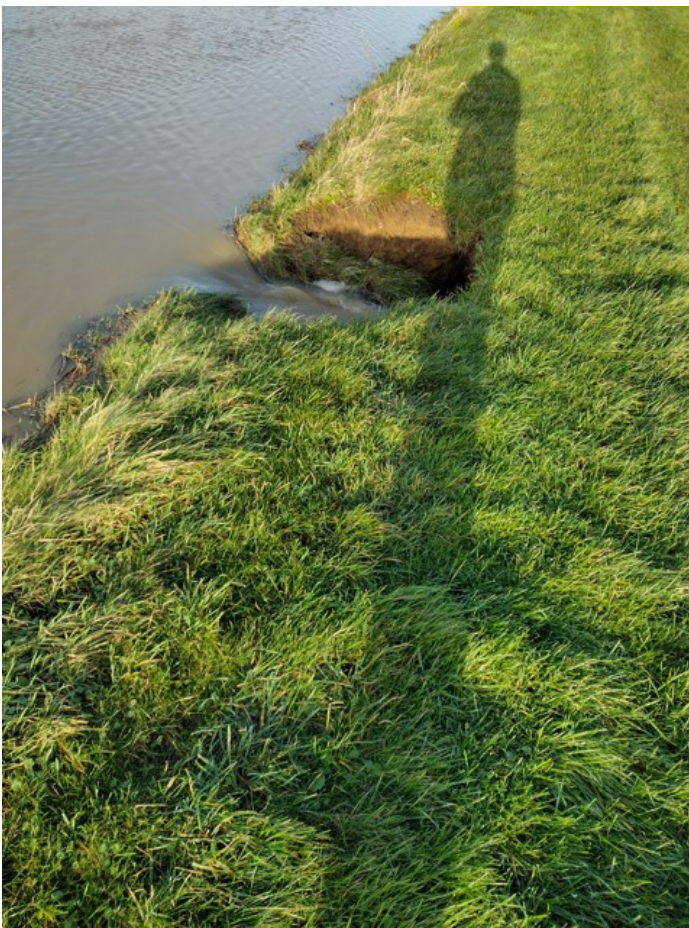
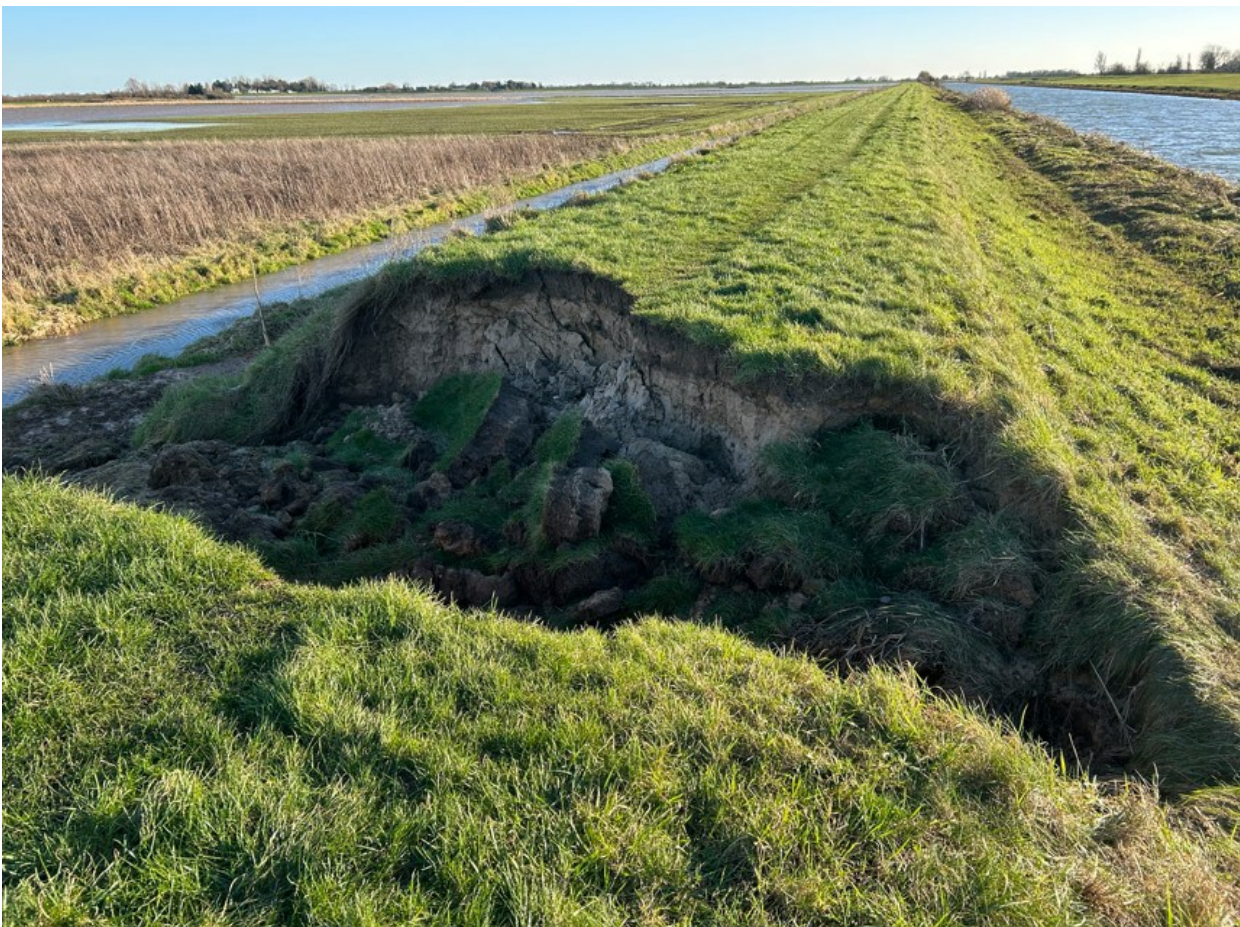
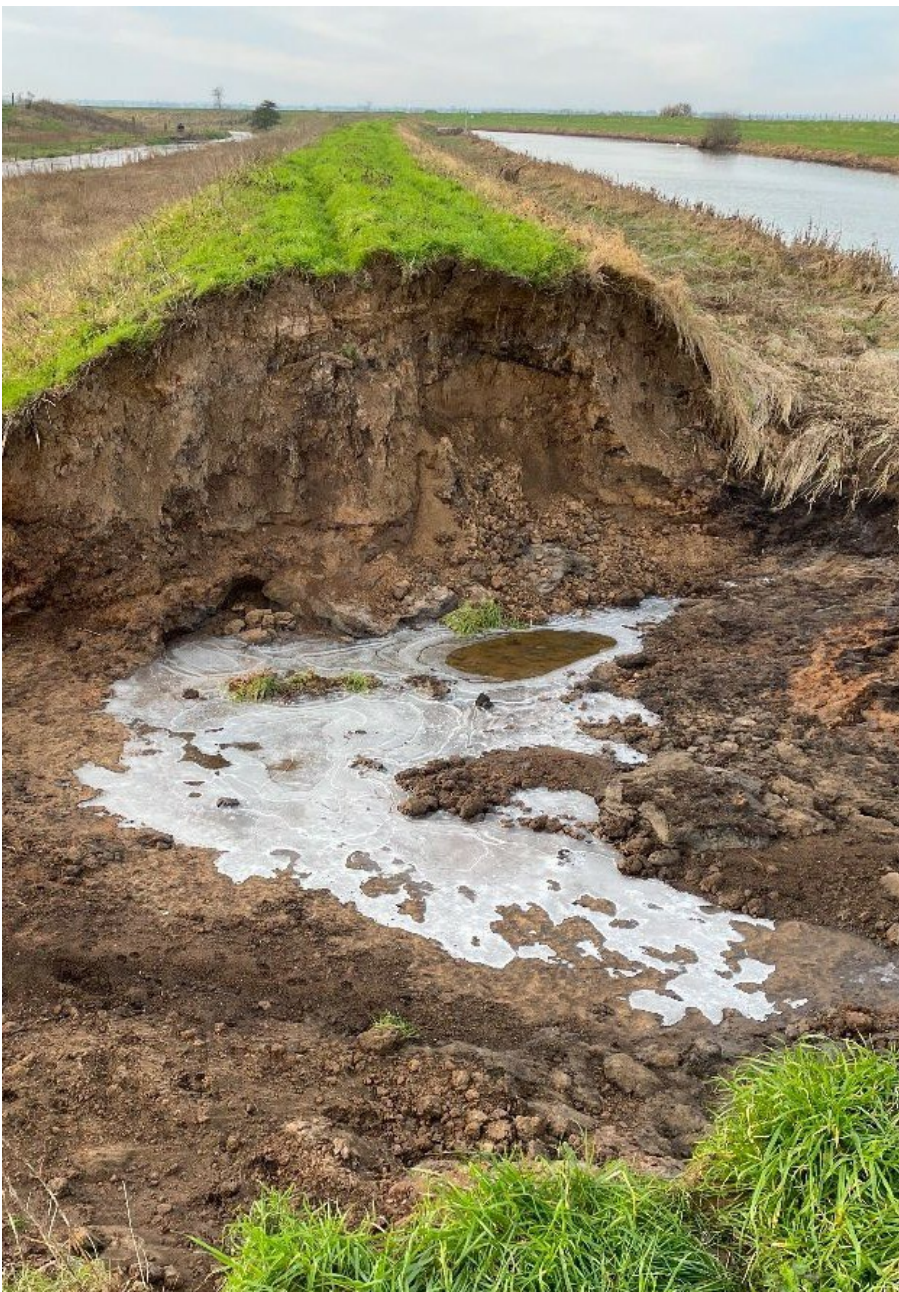
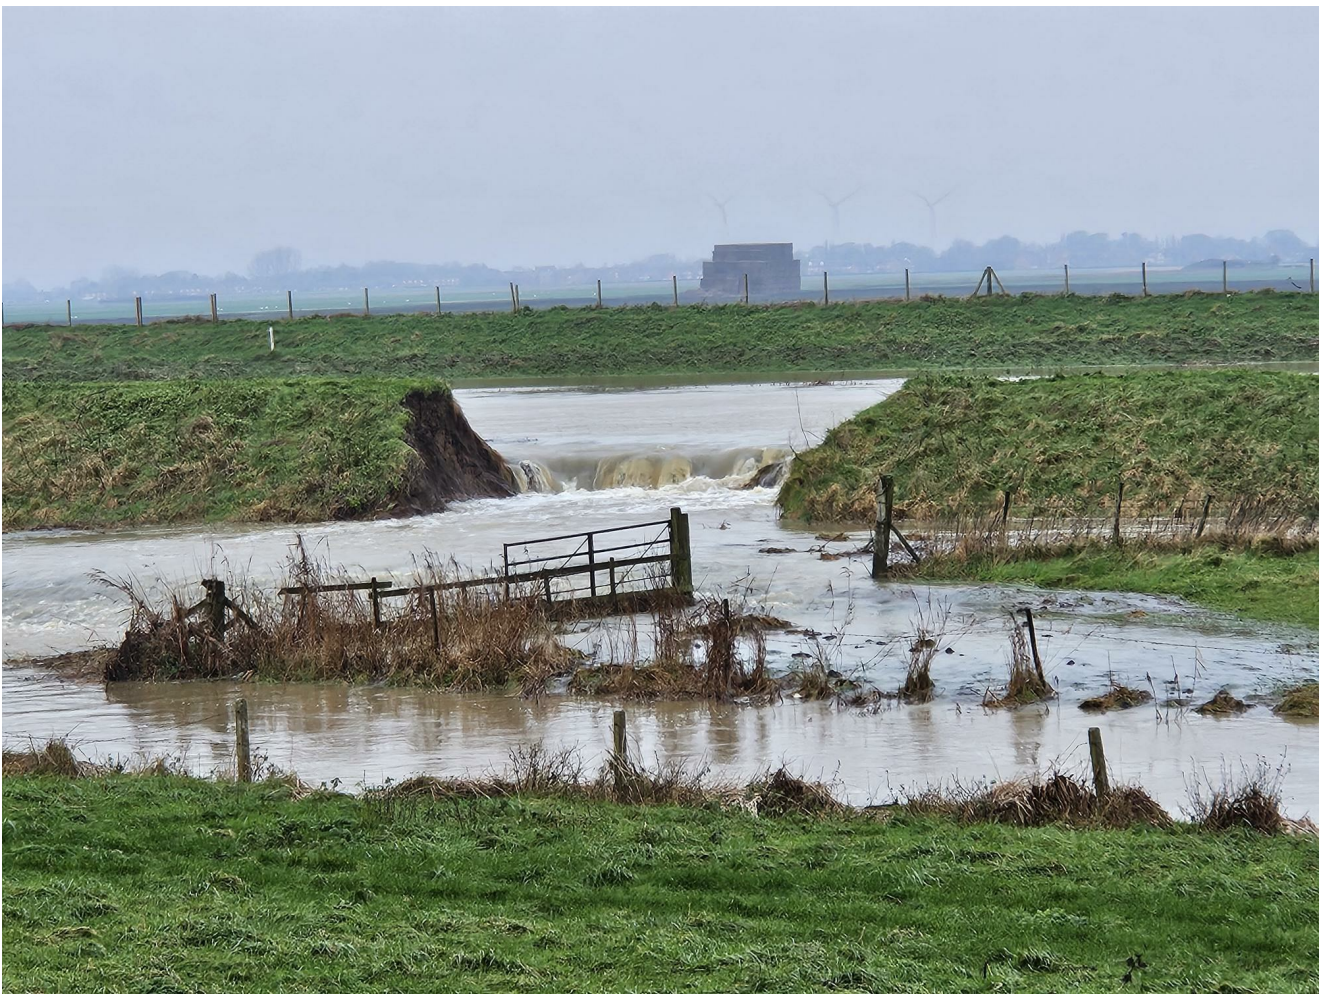
Two incidents occurred at this site, which is washland flood storage reservoir. The embankment affected was a cradge bank. This is a permanent bank constructed at a lower level to the main dam embankment. It would be overtopped before the main defence bank in a flood event. For the first incident, the undertaker noticed leakage during a planned annual inspection with the supervising engineer. The undertaker regularly monitored: the rate of leakage, any turbidity in the leaking water level of water in the river from where the leak was suspected. At the time of the first incident, the reservoir had not impounded water for a considerable time. If the cradge bank were to fail, the ability of the dam to safely sustain a sudden hydraulic impact load from the inflow was uncertain. Monitoring continued. A member of the public reported the second incident, which occurred 3 months later. The noticed a leak through the cradge bank between the river and the reservoir the reservoir was filling because of the leak. By the afternoon, the bank had breached. The undertaker inspected the bank. They found it was overtopping in many places, resulting in scour damage to the crest and slips on the downstream face. The undertakers inspected the bank using safe vantage points nearby and drone footage. Access to the dam during impoundment is not possible. The breach happened at a location which is designed to overflow and allow water into the reservoir. Due to this fact, it was not deemed a reservoir safety issue. It did impact the operation of the reservoir and could alter the flow regime of the river. The breach of the cradge bank did not impact the structural integrity of the main dam. The photos show the breach developing, during the event, and after the event. The undertaker investigated the cause of the incidents. The affected embankment is 400 years old and 20 km long. The structure is made from local material that has a low cohesive material content. There has been significant historical activity from badgers. Their former setts are often collapsed, which can't be seen from visual inspection. They are sufficiently porous to enable water to enter the embankment and lead to piping failure.

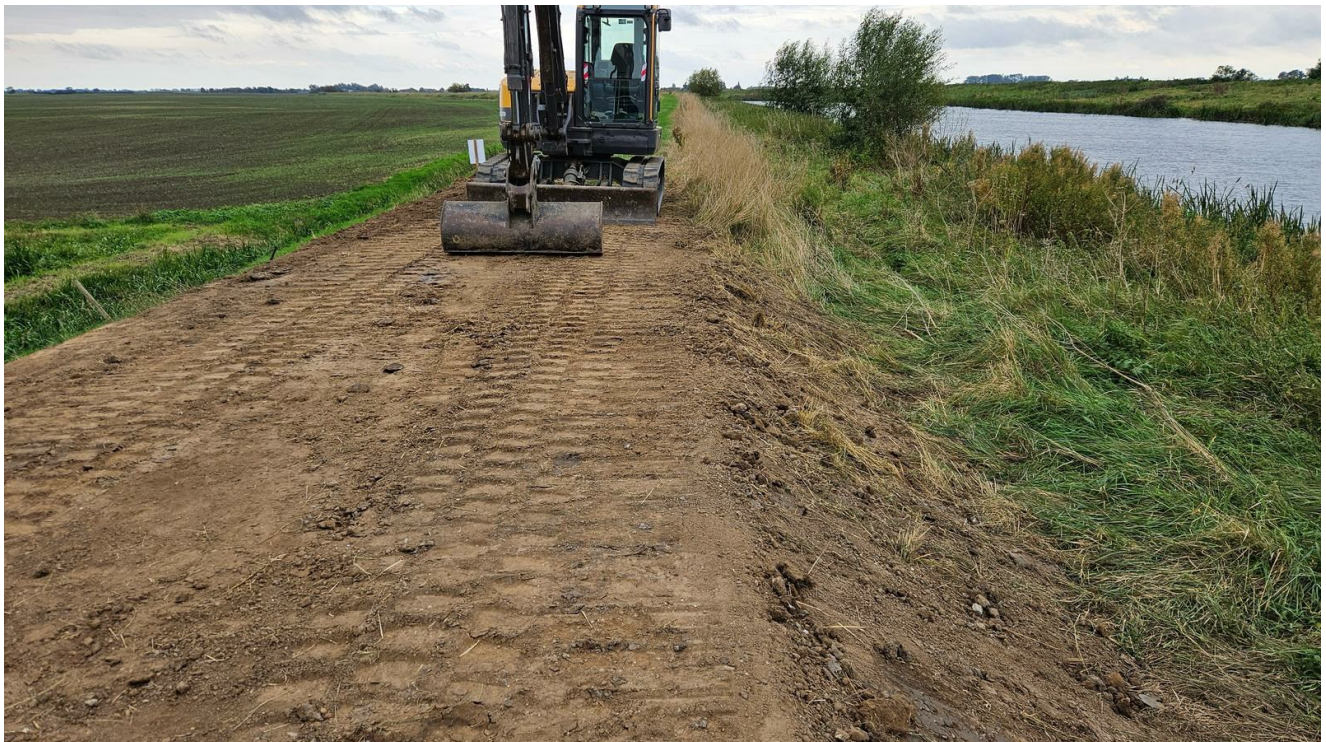
Acting to investigate and rectify leakage early may reduce the risk of more serious events happening afterwards.
