Leakage and breach of washland flood storage embankment

3249

England Regulator Reference No. 509 **Legal Status** Statutory **Reservoir Type** Impounding **Reservoir Capacity** 10M+ m3 **Year of Construction** < 1800 **Main Construction Type** Earth fill embankment **Dam Height** 2 - 4.99 metres **Dam Flood Category Hazard Class** High-risk reservoir Reservoir Use Other **Owner Type**

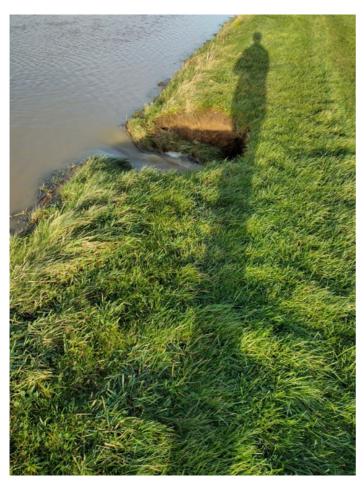
Leakage and breach of washland flood storage embankment

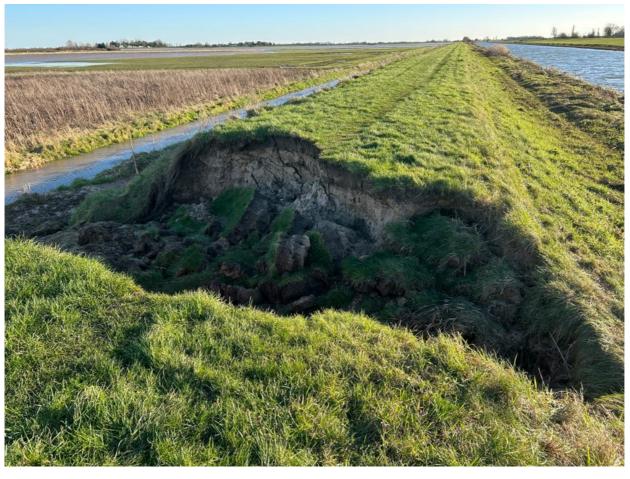
Leakage and breach of washland flood storage embankment

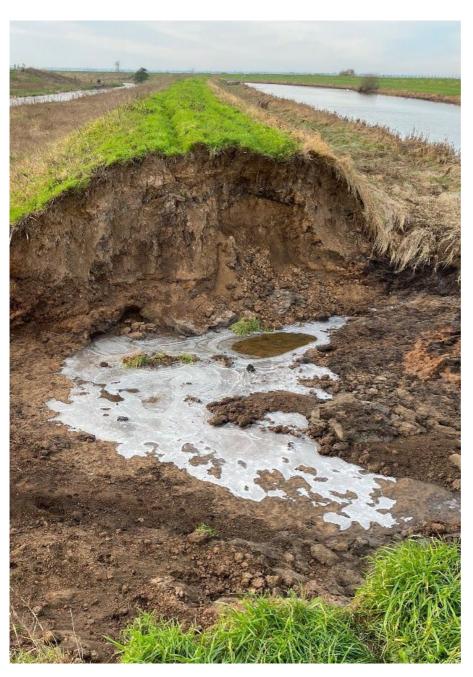
Leakage and breach of washland flood storage embankment

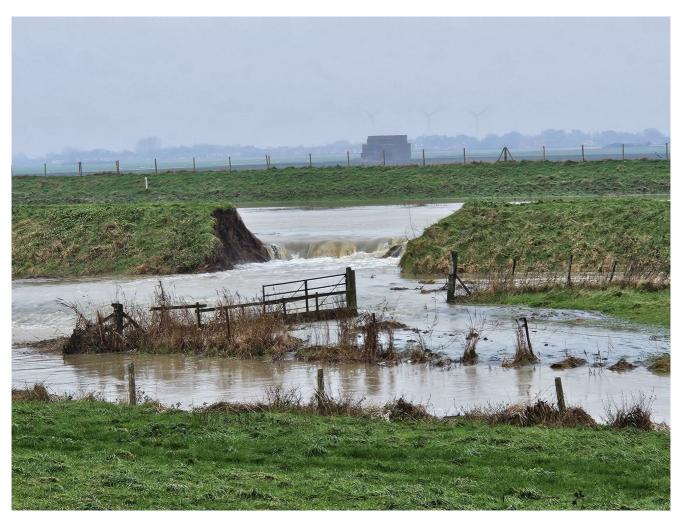
Leakage and breach of washland flood storage embankment

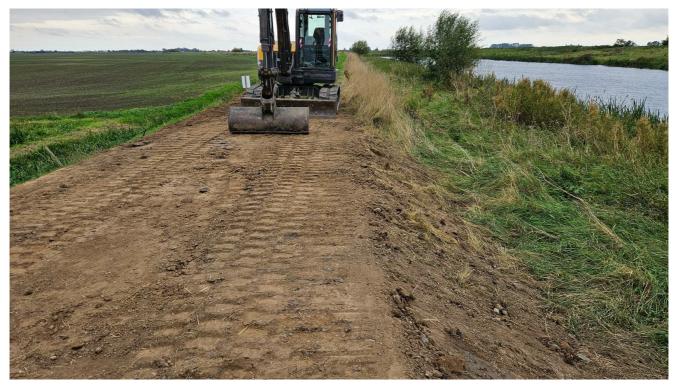
Leakage and breach of washland flood storage embankment
