Erosion from overflowing of flood storage reservoir on embankment not designed to spill

3253

02 September 2025

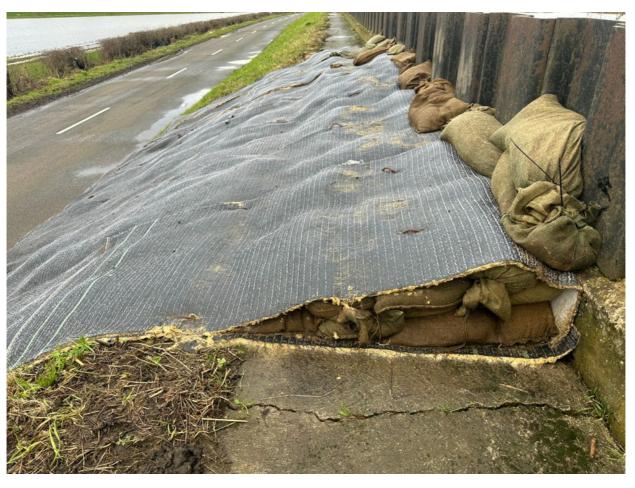
During Storm Babet, a river next to the dam overflowed the dam and caused erosion to the dry side of the bank. The embankment topsoil eroded down to the core material in various locations along the 600m length. The core is homogeneous and of good cohesive material, preventing further deterioration. The reservoir is an offline reservoir used to receive the tributary flow from a nearby beck. In an extreme flood event on the river, the reservoir can fill by overtopping the piled river defence. It acts as an unintended but high-level spill point. The piled river defences retain the upper 600mm of flood defence level. The piles are beyond their original design life and their length is thought to be around 5m long. The riverside exposed pile length is greater than the landward side by 2m. ?If the fill material was eroded away from the reservoir side, the piles would likely fail. Therefore, the embankment profile must be maintained to act as designed in a composite manner. This overtopping previously occurred in 2007. It caused minor scour at the piles interface with the embankment then. The undertakers constructed a splash pad post-2007 to alleviate the issue occurring again. In this incident, broad leaf plants such as docks and thistles worsened the erosion. Thistles and other stalks can cause micro-turbulence, exacerbating the erosive forces. The undertaker completed immediate temporary repairs once the flood flow had receded. During the incident, the local authority emergency response team closed a road to enable the emergency works. A QCE and the supervising engineer provided recommendations for short-, medium- and long-term repairs. The undertaker is looking to action these recommendations.

External erosion

Post flood actions were undertaken to carry out emergency temporary repairs to the embankment. The SE, also a QCE, was liaised with to ensure the temporary works design was appropriate should another flood event cause further overtopping. The On Site Plan was effectively put into action and appropriate personnel and resources deployed to action a recovery plan. The recovery plan involved liaison with professional partners to enable emergency road closures to undertake the temporary repair works. The main materials used were sandbags and bentonite geotextile fabric to act as robust erosion protection to the areas of scour.
