3253

Erosion from overflowing of flood storage reservoir on embankment not designed to spill

514

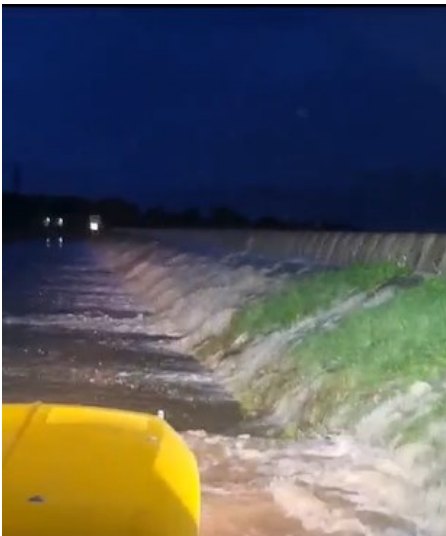
During Storm Babet, a river next to the dam overflowed the dam and caused erosion to the dry side of the bank. The embankment topsoil eroded down to the core material in various locations along the 600m length. The core is homogeneous and of good cohesive material, preventing further deterioration. The reservoir is an offline reservoir used to receive the tributary flow from a nearby beck. In an extreme flood event on the river, the reservoir can fill by overtopping the piled river defence. It acts as an unintended but high-level spill point. The piled river defences retain the upper 600mm of flood defence level. The piles are beyond their original design life and their length is thought to be around 5m long. The riverside exposed pile length is greater than the landward side by 2m. If the fill material was eroded away from the reservoir side, the piles would likely fail. Therefore, the embankment profile must be maintained to act as designed in a composite manner. This overtopping previously occurred in 2007. It caused minor scour at the piles interface with the embankment then. The undertakers constructed a splash pad post-2007 to alleviate the issue occurring again. In this incident, broad leaf plants such as docks and thistles worsened the erosion. Thistles and other stalks can cause micro-turbulence, exacerbating the erosive forces. The undertaker completed immediate temporary repairs once the flood flow had receded. During the incident, the local authority emergency response team closed a road to enable the emergency works. A QCE and the supervising engineer provided recommendations for short-, medium- and long-term repairs. The undertaker is looking to action these recommendations.

Erosion from overflowing of flood storage reservoir on embankment not designed to spill - Incident Image

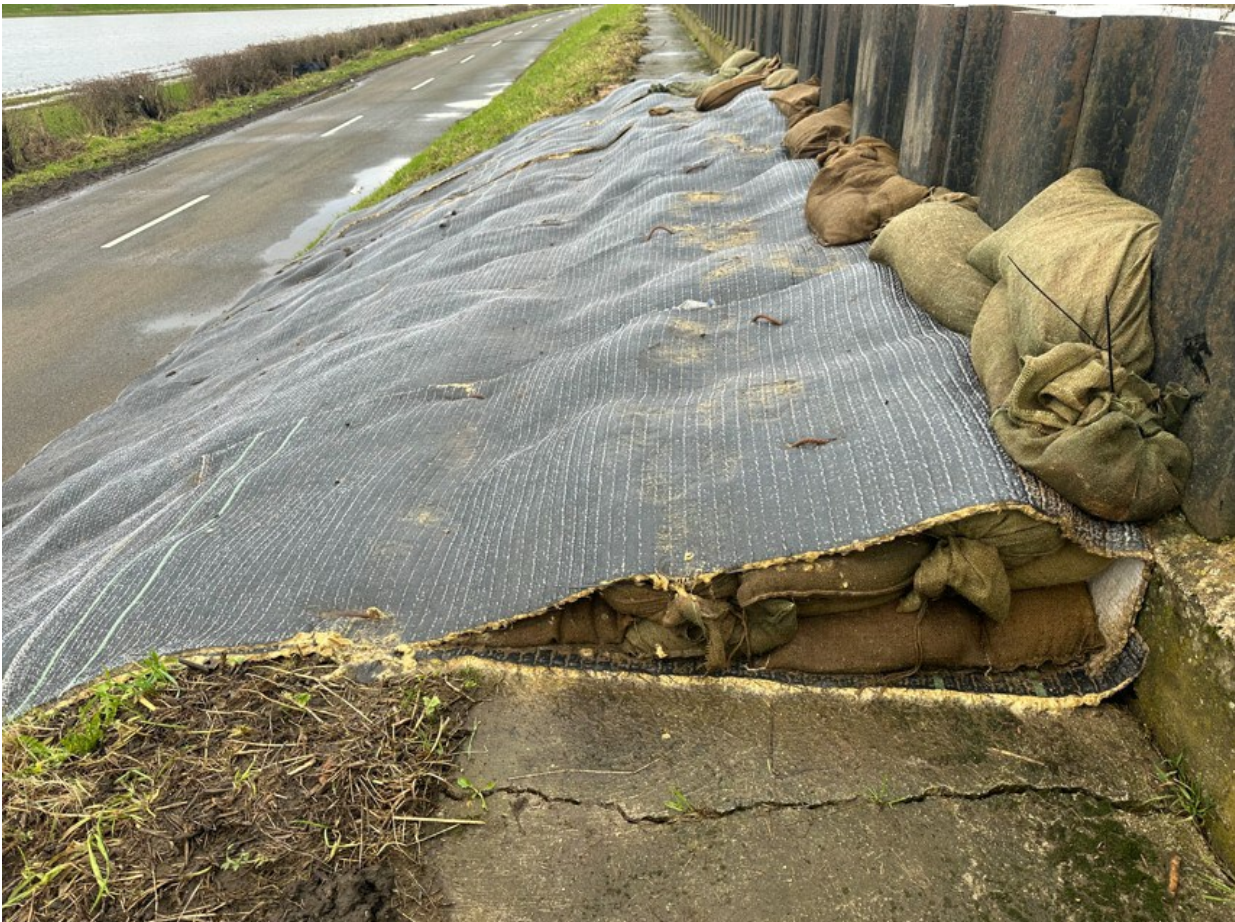
- Design shortcoming
- Maintenance shortcoming

- External erosion

Erosion from overflowing of flood storage reservoir on embankment not designed to spill - Cause Image
