3266

Collapse of a brick outlet culvert

England

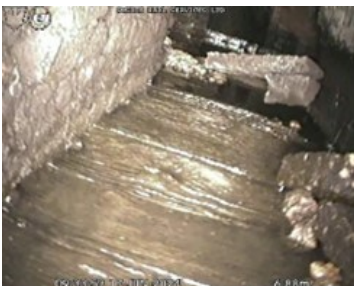
During the routine 6 monthly testing of the penstock valve, on the upstream end of an overflow culvert at an upper pond a large amount of brick rubble was carried through in the discharge to the lower pond. The penstock valve was immediately closed. The overflow culvert runs through the centre of the earth embankment dam and is 32 m in length. The upstream 20 m comprises a circular 530 mm dia concrete pipe. The final 12 m length comprised a brick arch culvert, 1080 mm high, 610 mm wide. There were no visible signs of embankment movement or crest settlement. A CCTV survey was undertaken, entering the culvert from the downstream end only, which identified a large void in the brick culvert section 8 m from the downstream end of the culvert. This survey also identified that the invert of the brick culvert comprised timber sleepers. Following consultation with the last Inspecting Engineer, a precautionary and controlled drawdown commenced. A further CCTV survey was completed, entering the culvert from both upstream and downstream ends, to help ascertain further information for the most appropriate repair. This revealed the full scale of the void, approximately 3 m in length and extending approximately 1.5 m away from either side of the original line of the brick culvert. The crest path was closed to both pedestrian and vehicular traffic and temporary pumps were brought in to continue the pre-cautionary drawdown at a rate of between 300 and 400 mm per day and hold the water level at an agreed level whilst a design solution was developed and repairs to the overflow were undertaken.

Collapse of a brick outlet culvert - Incident Image

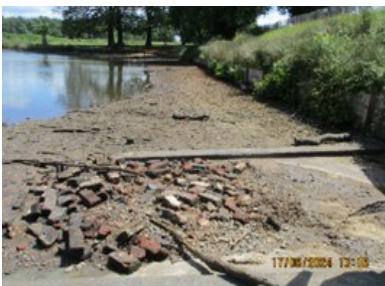
Collapse of a brick outlet culvert - Incident Image

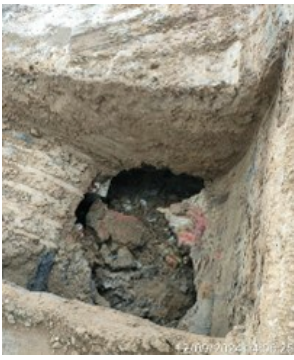
Collapse of a brick outlet culvert - Incident Image

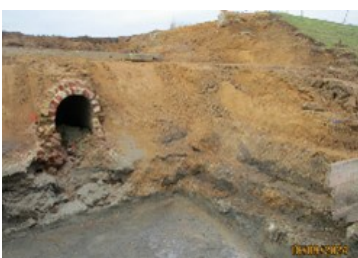
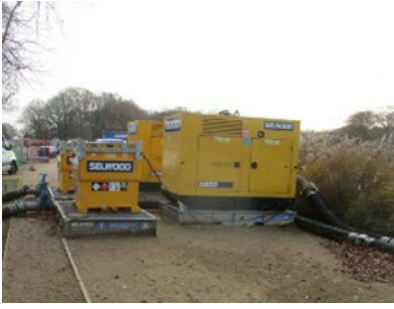
The root cause of the incident was failure of the brick culvert overflow leading to potential instability of the homogeneous earth embankment dam.

Collapse of a brick outlet culvert - Cause Image
