3268

Unpermitted excavation on a flood storage reservoir

537

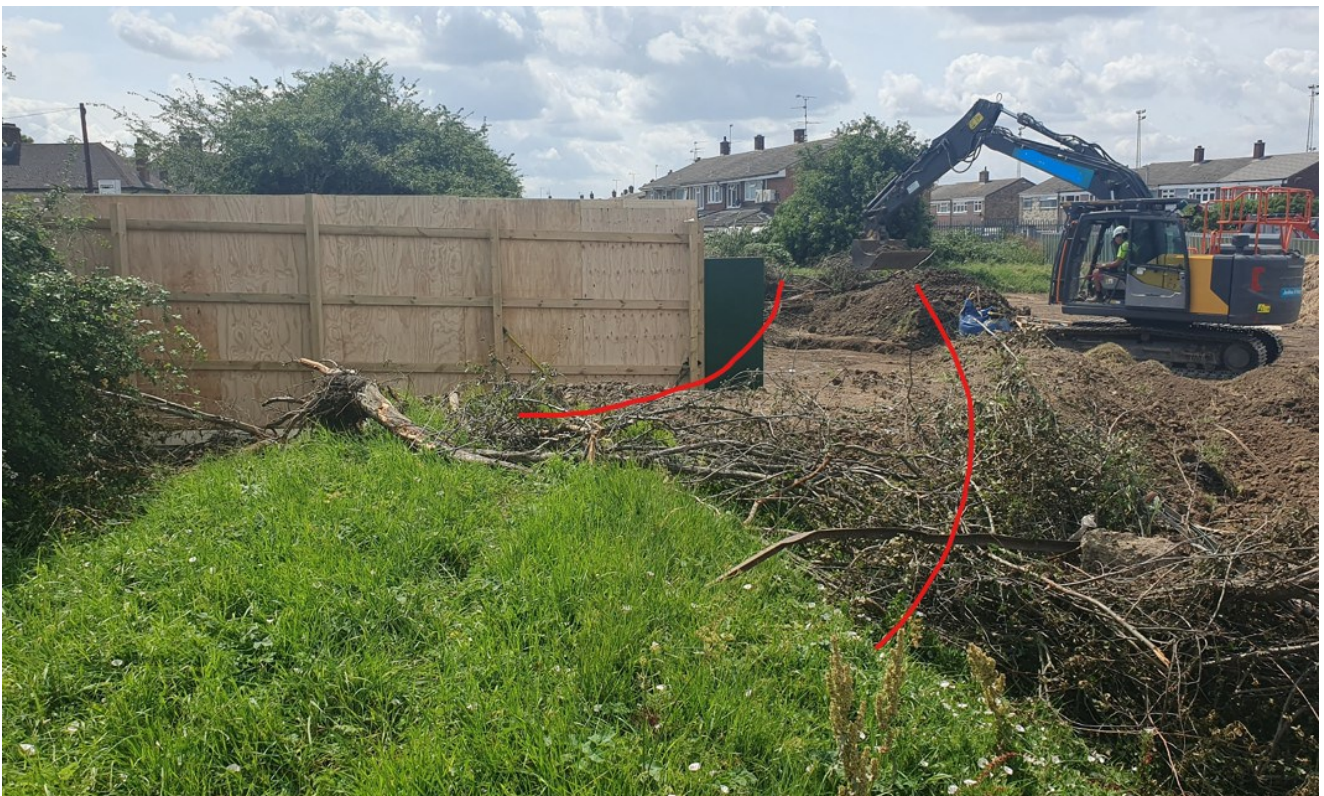
Unpermitted excavation on a flood storage reservoir - Incident Image

During routine maintenance works, the undertaker of a flood storage reservoir noticed that someone had excavated into the dam. A contractor working on behalf of a developer had removed a section of the bank. The undertaker notified the supervising engineer and investigated the cause. The undertaker and supervising engineer visited the contractor within 24 hours. They instructed them to stop all works and reconstruct the embankment. The reconstruction was completed under supervision of the supervising engineer. The available documents on the Local Planning Authority website did not make it clear what the exact approved details for works on the dam were. The Environment Agency had been formally consulted, and they had provided details of their required conditions. Work on site suggested the contractor was not aware of the required conditions. The situation appears to have occurred by a lack of suitable communication. The undertakers have since discussed with the planning authority: how the incident was able to occur what corrective actions should be taken measures to prevent a reoccurrence.

Rapid attendance of undertaker and SE to construction site and instruction to cease works, and reinstate bank.

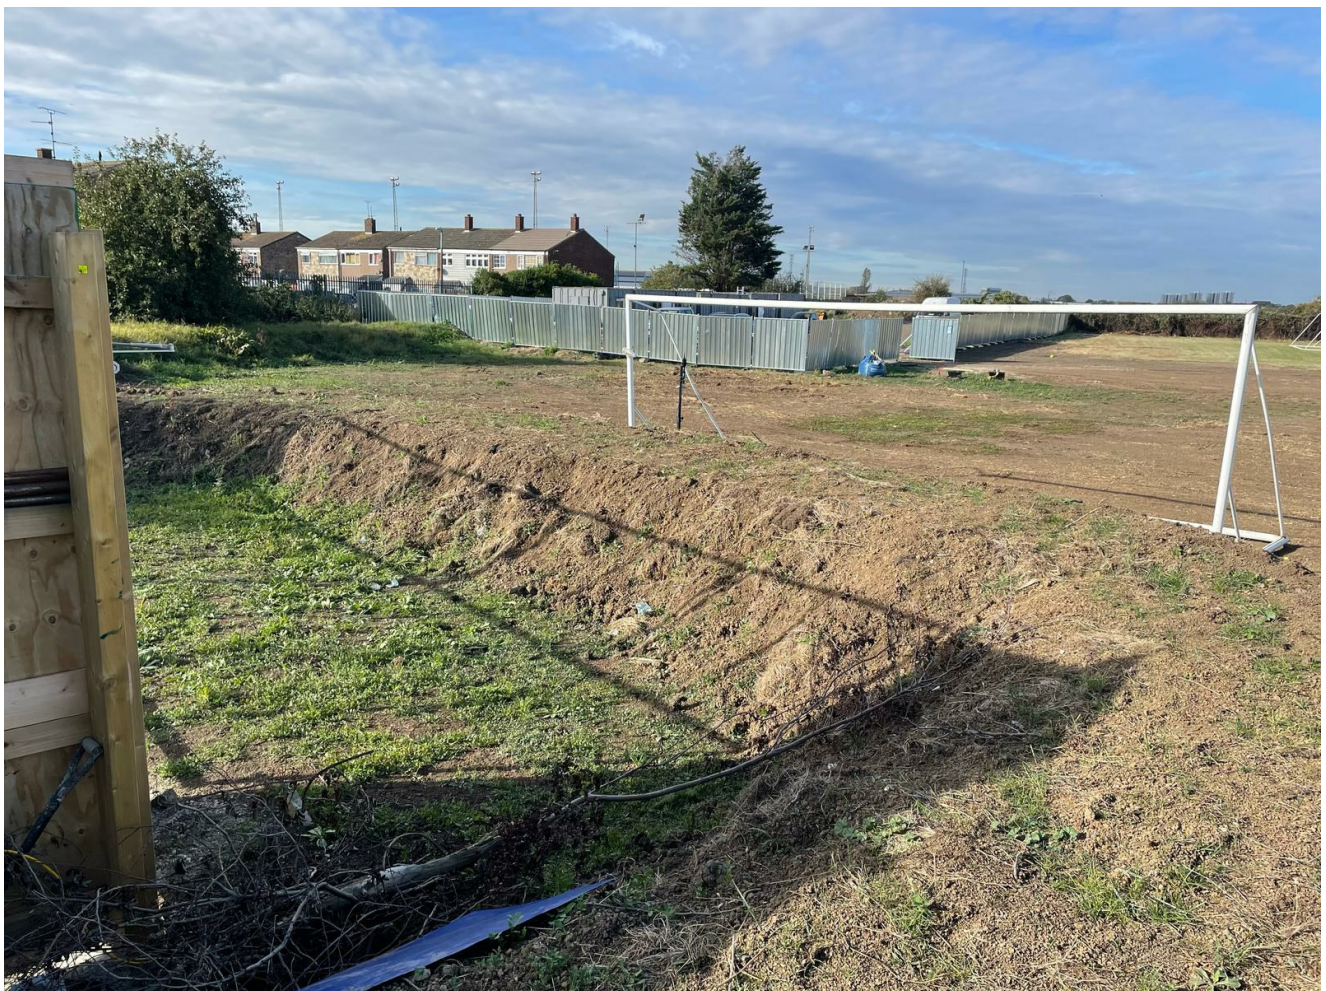
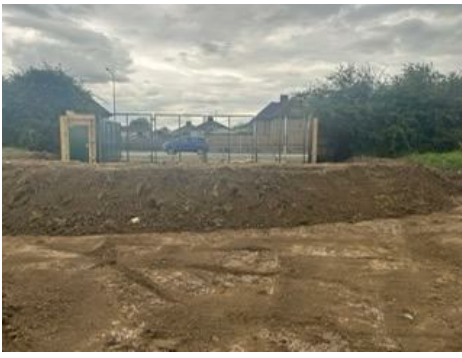
Unpermitted excavation on a flood storage reservoir - Cause Image

- External erosion

There are investigations ongoing to ascertain the cause of the incident. The initial investigation indicates either a failure in communication between the LPA and the EA (in relation to application and discharge of planning conditions) and the contractor working for the developer or failure by the contractor to comply with approved conditions.

Improved communication is required to ensure all aspects of any proposed development that might affect a reservoir dam are encompassed with relevant conditions attached to any planning permission granted. It is advisable to involve the Supervising Engineer into the consultation process by the undertaker for this purpose. A suitable monitoring process of the works after planning permission has been granted should be conducted by the undertaker to ensure all works comply with the approved details and conditions.
