3269

Longitudinal cracking of a thick topsoil layer on an embankment dam did not self heal, leading to a translational slip

Earth fill embankment

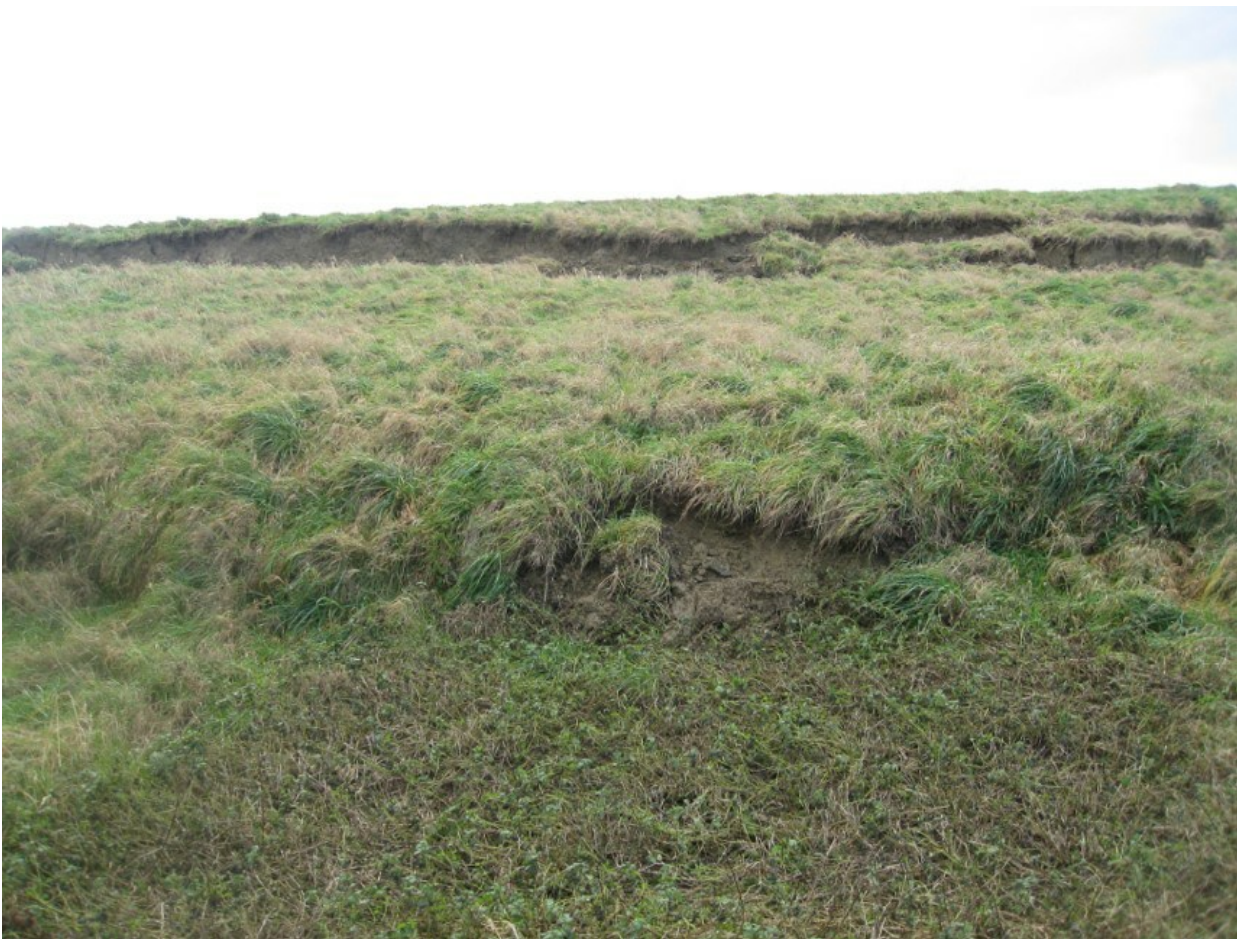
On the morning of 6th January estate personnel observed that a slip had occurred on the downstream face of the northern embankment of the reservoir. The area was visually inspected; it was observed that there was no clear ongoing movement or discharge of water, but that the toe area around the entire embankment perimeter was very wet (this is consistent with very heavy rainfall of approximately 60mm on the evening of 5th January). The Undertaker's representative was contacted, and he then advised the Supervising Engineer. The Supervising Engineer visited the site on 6th January and discussed his findings with the Undertaker and QCE. A summary of the site visit notes is below: Reservoir level -10.8 on the ramp (I estimate around 2.5m below TWL) The area of the slip on the downstream face is approx. 80m length at the western end of the northern bank. No signs of movement or of extensive longitudinal cracking on the remaining perimeter. At the area of the slip the upstream face and crest appear undisturbed, slip extends from approx. downstream edge of the crest to approx. 2m upslope from the toe. No signs of increased seepage or other distress and the rotational component of the movement appears pretty small so appears to be a relatively shallow slip perhaps 1 to 2m deep in places. Note this would be consistent with this being entirely within the non-structural additional topsoil thickness noted in the annex to the CoEEoW. Crest width in this location was measured at 9m this is significantly wider than the nominal 4m shown in the record drawings in the annex to the CoEEoW so suggests the topsoil wedge could be up to 2m thick. During construction it is understood that there was a significant surplus volume of topsoil / subsoil material from the reservoir footprint that was unsuitable for use as structural embankment fill. According to the Annex to the Certificate of Efficient Execution of Works, this material was placed on the downstream shoulder of the embankment; investigations following the incident indicate that the thickness of material placed was approximately 1.5m to 2m. The last S10 report (2018) notes that "The crest carries a significant thickness of topsoil which has desiccated during the recent and prolonged wet weather. I consider that these cracks will self-heal when the autumn/winter rains come and moisture contents rise. If the cracks do not "heal" then I recommend that the cracks be filled with a dry sand/topsoil/grass seed mix poured into the fissures." The Supervising Engineer has subsequently observed desiccation cracking on the crest and downstream face; however, this has typically self-healed in the autumn/winter. It appears that there was a longitudinal desiccation crack along the downstream face of the northern embankment, just below the crest, that did not self-heal over the autumn of 2024. During the exceptionally heavy rainfall of the evening of 5th January 2025, this crack filled with water, resulting in lubrication of the interface between the non-structural topsoil and the clay fill beneath. This caused a translational failure of the ~1.5m to 2m thick topsoil wedge. A section of embankment approximately 80m in length was affected, and the topsoil wedge moved downslope by approximately 2m.

Longitudinal cracking of a thick topsoil layer on an embankment dam did not self heal, leading to a translational slip - Incident Image

All slipped material was removed and the downstream face reinstated by placing 200mm depth of topsoil. Surplus material placed in a low berm at the toe of the embankment, with cross-fall away from the embankment to provide surface water drainage and prevent ponding at the embankment toe. The reduction in topsoil thickness at the location of the slip reduces the likelihood of a similar slip reoccurring in this location. It is noted that non-structural topsoil / subsoil thickness of 1.5m to 2m remain around the rest of the reservoir embankments; as there has been no mass movement in these areas no works have been undertaken. Surveillance to be implemented by the Undertaker and Supervising Engineer to monitor for persistent longitudinal dessication cracks that do not self-heal in Autumn.

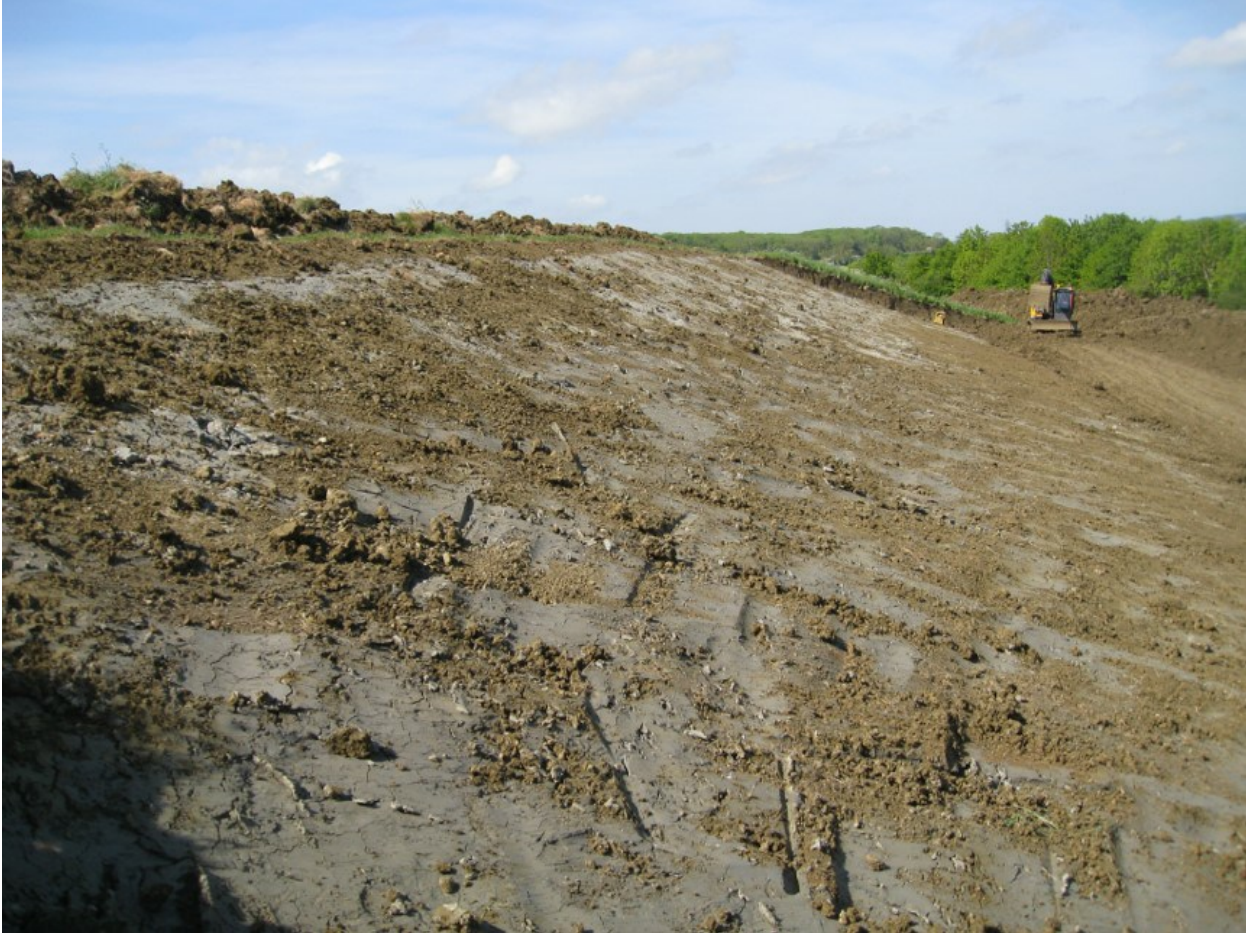
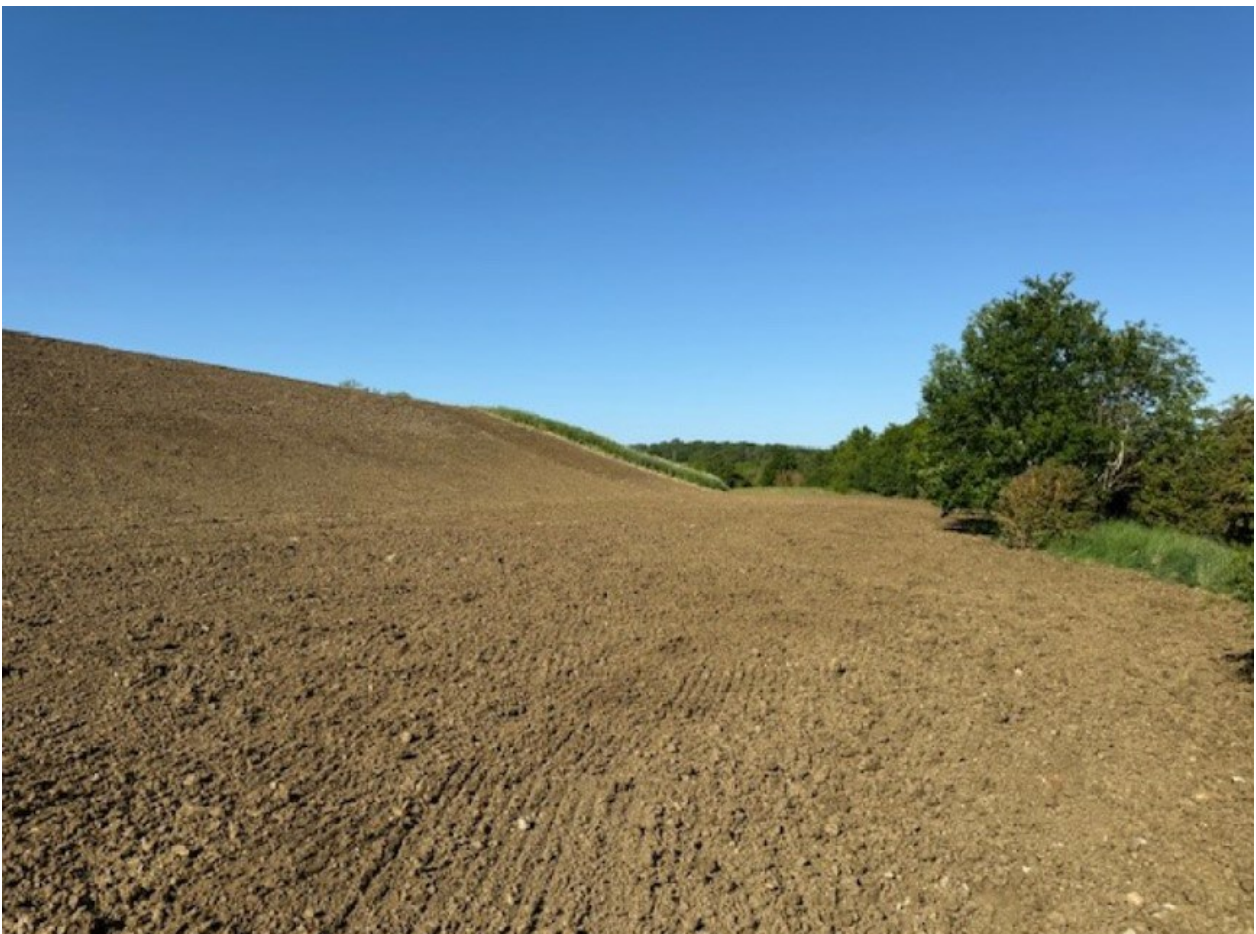
During construction it is understood that there was a significant surplus volume of topsoil / subsoil material from the reservoir footprint that was unsuitable for use as structural embankment fill. According to the Annex to the Certificate of Efficient Execution of Works, this material was placed on the downstream shoulder of the embankment; investigations following the incident indicate that the thickness of material placed was approximately 1.5m to 2m. The last S10 report (2018) notes that "The crest carries a significant thickness of topsoil which has desiccated during the recent and prolonged wet weather. I consider that these cracks will self-heal when the autumn/winter rains come and moisture contents rise. If the cracks do not "heal" then I recommend that the cracks be filled with a dry sand/topsoil/grass seed mix poured into the fissures." The Supervising Engineer has subsequently observed desiccation cracking on the crest and downstream face; however, this has typically self-healed in the autumn/winter. It appears that there was a longitudinal desiccation crack along the downstream face of the northern embankment, just below the crest, that did not self-heal over

the autumn of 2024. During the exceptionally heavy rainfall of the evening of 5th January 2025, this crack filled with water, resulting in lubrication of the interface between the non-structural topsoil and the clay fill beneath. This caused a translational failure of the ~1.5m to 2m thick topsoil wedge. A section of embankment approximately 80m in length was affected, and the topsoil wedge moved downslope by approximately 2m.

Longitudinal cracking of a thick topsoil layer on an embankment dam did not self heal, leading to a translational slip - Cause Image
