02 September 2025 Case ID# 3269 Title Longitudinal cracking of a thick topsoil layer on an embankment dam did not self heal, leading to a translational slip **Nation** England Regulator Reference No. 539 **Legal Status** Statutory **Reservoir Type** Non-impounding **Reservoir Capacity** 10 - 24,999m3 **Year of Construction** 1990 - 2009 **Main Construction Type** Earth fill embankment **Dam Height** 5 - 9.99 metres **Dam Flood Category** В **Hazard Class** High-risk reservoir Reservoir Use

Longitudinal cracking of a thick topsoil layer on an embankment dam did not self heal, leading to a translational slip

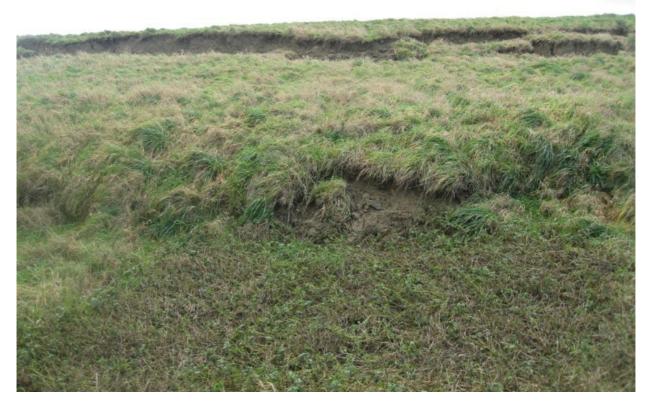
On the morning of 6th January estate personnel observed that a slip had occurred on the downstream face of the northern embankment of the reservoir. The area was visually inspected; it was observed that there was no clear ongoing movement or discharge of water, but that the toe area around the entire embankment perimeter was very wet (this is consistant with very heavy rainfall of approximately 60mm on the evening of 5th January). The Undertaker's representative was contacted, and he then advised the Supervising Engineer. The Supervising Engineer visited the site on 6th January and discussed his findings with the Undertaker and QCE. A summary of the site visit notes is below: Reservoir level -10.8 on the ramp (I estimate around 2.5m below TWL) The area of the slip on the downstream face is approx. 80m length at the western end of the northern bank. No signs of movement or of extensive longitudinal cracking on the remaining perimeter. At the area of the slip the upstream face and crest appear undisturbed, slip extends from approx. downstream edge of the crest to approx. 2m upslope from the toe. No signs of increased seepage or other distress and the rotational component of the movement appears pretty small so appears to be a relatively shallow slip perhaps 1 to 2m deep in places. Note this would be consistent with this being entirely within the non-structural additional topsoil thickness noted in the annex to the CoEEoW. Crest width in this location was measured at 9m this is significantly wider than the nominal 4m shown in the record drawings in the annex to the CoEEoW so suggests the topsoil wedge could be up to 2m thick. During construction it is understood that there was a significant surplus volume of topsoil / subsoil material from the reservoir footprint that was unsuitable for use as structural embankment fill. According to the Annex to the Certificate of Efficient Execution of Works, this material was placed on the downstream shoulder of the embankment; investigations following the incident indicate that the thickness of material placed was approximately 1.5m to 2m. The last S10 report (2018) notes that "The crest carries a significant thickness of topsoil which has desiccated during the recent and prolonged wet weather. I consider that these cracks will self-heal when the autumn/winter rains come and moisture contents rise. If the cracks do not "heal" then I recommend that the cracks be filled with a dry sand/topsoil/grass seed mix poured into the fissures." The Supervising Engineer has subsequently observed desiccation cracking on the crest and downstream face; however, this has typically self-healed in the autumn/winter. It appears that there was a longitudinal desiccation crack along the downstream face of the northern embankment, just below the crest, that did not self-heal over the autumn of 2024. During the exceptionally heavy rainfall of the evening of 5th January 2025, this crack filled with water, resulting in lubrication of the interface between the non-structural topsoil and the clay fill beneath. This caused a translational failure of the ~1.5m to 2m thick topsoil wedge. A section of embankment approximately 80m in length was affected, and the topsoil wedge moved downslope by approximately 2m.

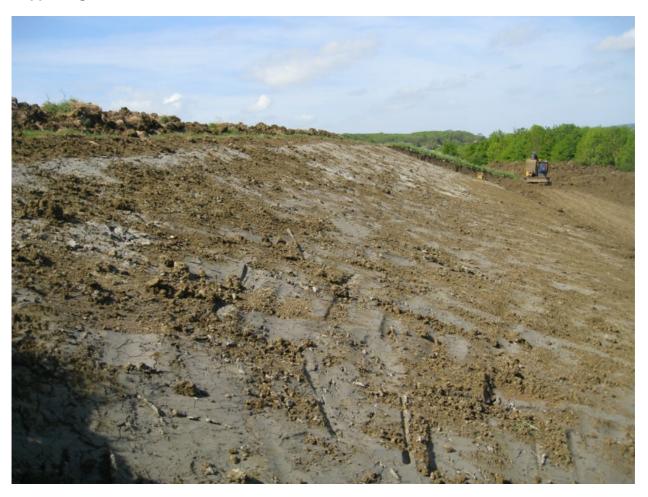
During construction it is understood that there was a significant surplus volume of topsoil / subsoil material from the reservoir footprint that was unsuitable for use as structural embankment fill. According to the Annex to the Certificate of Efficient Execution of Works, this material was placed on the downstream shoulder of the embankment; investigations following the incident indicate that the thickness of material placed was approximately 1.5m to 2m. The last S10 report (2018) notes that "The crest carries a significant thickness of topsoil which has desiccated during the recent and prolonged wet weather. I consider that these cracks will self-heal

when the autumn/winter rains come and moisture contents rise. If the cracks do not "heal" then I recommend that the cracks be filled with a dry sand/topsoil/grass seed mix poured into the fissures." The Supervising Engineer has subsequently observed desiccation cracking on the crest and downstream face; however, this has typically self-healed in the autumn/winter. It appears that there was a longitudinal desiccation crack along the downstream face of the northern embankment, just below the crest, that did not self-heal over the autumn of 2024. During the exceptionally heavy rainfall of the evening of 5th January 2025, this crack filled with water, resulting in lubrication of the interface between the non-structural topsoil and the clay fill beneath. This caused a translational failure of the ~1.5m to 2m thick topsoil wedge. A section of embankment approximately 80m in length was affected, and the topsoil wedge moved downslope by approximately 2m.

Longitudinal cracking of a thick topsoil layer on an embankment dam did not self heal, leading to a translational slip

All slipped material was removed and the downstream face reinstated by placing 200mm depth of topsoil. Surplus material placed in a low berm at the toe of the embankment, with cross-fall away from the embankment to provide surface water drainage and prevent ponding at the embankment toe. The reduction in topsoil thickness at the location of the slip reduces the likelihood of a similar slip reoccurring in this location. It is noted that non-structural topsoil / subsoil thickness of 1.5m to 2m remain around the rest of the reservoir embankments; as there has been no mass movement in these areas no works have been undertaken. Surveillance to be implemented by the Undertaker and Supervising Engineer to monitor for persistent longitudinal dessication cracks that do not self-heal in Autumn.

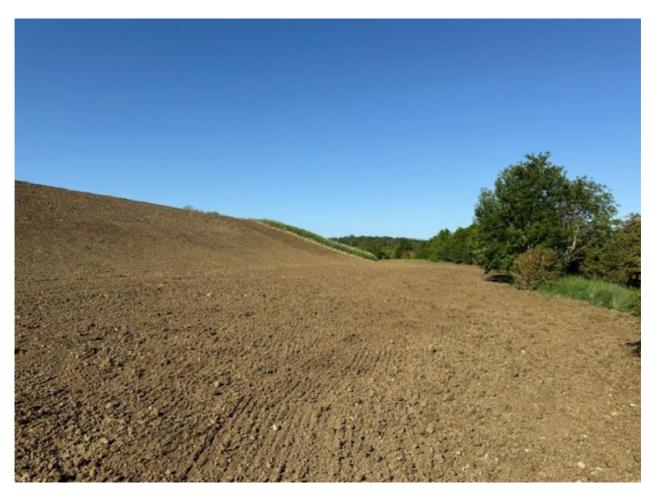
Longitudinal cracking of a thick topsoil layer on an embankment dam did not self heal, leading to a translational slip
