3342

# Wales Regulator Reference No. 80 **Legal Status** Statutory **Reservoir Type** Impounding **Reservoir Capacity** 10 - 24,999m3 **Year of Construction** 1800 - 1849 **Main Construction Type** Earth fill embankment **Dam Height** 2 - 4.99 metres **Dam Flood Category** В **Hazard Class** High-risk reservoir Reservoir Use • Flood risk management

Scour damage to spillway channel following storms and resulting reservoir impoundments

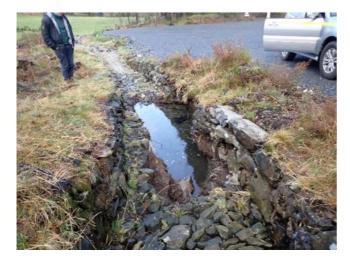
Following routine surveillance, the Supervising Engineer was alerted of scour dam to the old narrow masonry spillway channel following storms in early January 2025 and resulting in reservoir impoundments. The hole in the spillway started at around 4pm from the upstream entrance of the spillway, which was approximately 4.5m in length / 1.5m in width and around 1m deep. SE attended site and initiated telephone discussions with the QCE. Remedial works were agreed on later that day, including MIOS improvement works to replace the existing spillway.

Scour damage to spillway channel following storms and resulting reservoir impoundments

Old narrow and inadequate masonry spillway channel deteriorating following storm / flood events, leading to scour damage. Effectiveness of permanent measures: the new spillway facilities and channel were successfully tested during a heavy rainfall event (albeit at a very low water level compared to the safety check flood level) in September 2025, with a water depth of 140mm observed flowing through the new main spillway structure and channel.

None following incident: - the new main spillway structure and channel, including the new auxiliary spillway facility, which were built in Summer 2025, have been designed to reservoir category B standards in terms of capacity and construction material (i.e. design flood 1 in 1000 year and safety check flood 1 in 10,000 year), and subsequently signed off and certified by the QCE – the new spillway facilities are therefore a vast improvement in terms of capacity and robustness. The reservoir freeboard was also improved during the Summer 2025 works.
