Basic Details

Publish Date 28 October 2025 Case ID# 3345 Title Partial failure of outlet pipe leading to internal erosion in flood storage reservoir, exacerbated by a blocked debris screen **Nation** England Regulator Reference No. 533 **Legal Status** Statutory **Reservoir Type** Impounding **Reservoir Capacity** 100,000 - 499,999m3 **Year of Construction** 1970 - 1989 **Main Construction Type** Earth fill embankment **Dam Height** 5 - 9.99 metres **Dam Flood Category Hazard Class** High-risk reservoir Reservoir Use

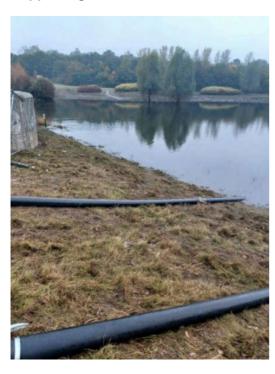
A previously unknown failure of the outlet pipe caused internal erosion, where fines were washed down causing a sinkhole on the upstream face of the dam. A blocked debris screen from grass cuttings on the outlet meant the flood storage reservoir was held at a higher level than normal. This triggered investigation of the condition of the outlet pipe and identification of the partial failure of the pipe.

Partial failure of outlet pipe leading to internal erosion in flood storage reservoir, exacerbated by a blocked debris screen
