3372

Incorrect gate operation damaged the gate frame causing inoperability

This site is classed as an impounding flood storage reservoir to prevent downstream flooding during high rainfall. It is mostly dry with a stream running through and only floods the reservoir area in extremely high flows. The outlet is controlled by a hydraulically operated gate which sits halfway open. This allows a steady flow of water whilst managing downstream flood risk. The gate has stops which rest on a beam, called its 'home position'. This is to prevent the gate closing during a loss of hydraulics or hydraulic creep.

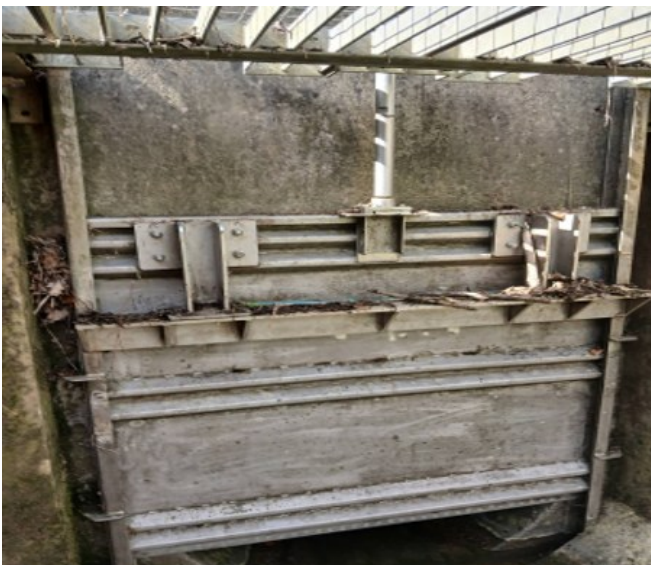
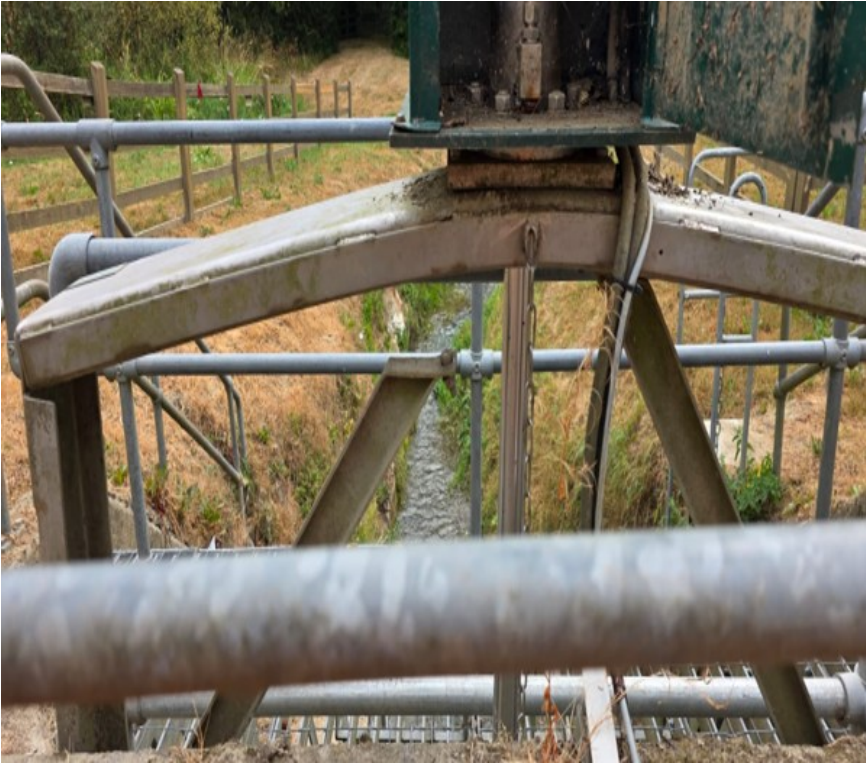
During a planned maintenance event, the operational key switch was moved from auto to manual and the gate was operated to close. However, the gate was still resting on the stops. With the pressure exerted on the stops, they did not move which caused the frame to distort. The frame bowed upwards and the strengthening bars broke away from the locating points on the frame. The Reservoir was empty of the time of the event so there was no uncontrolled release of water caused by the damage to the structure. There is no potential for this to have been the case, and the damage solely effects the ability to drawdown water levels during flood conditions.

Gates resting on their stops

The penstock was incorrectly operated (switched to manual and set to close) when it was already resting on its stops, which caused distortion of the top member of the gate frame.

1. Remove the hydraulic cylinder and top of gate with HIAB
2. CARE must be taken with the cylinder as the positional instrument on top is expensive and has a lead time of 26 weeks
3. Contractor to straighten the top of the gate bracing brackets , and twisted side of gate.
4. Return, replace top of gate and hydraulic cylinder with HIAB

1. Remove manual button for down , or replace with a key switch
2. Reduce hydraulic pressure if possible
3. Toolbox talk training for the team talking through operational manual
