3373

Void formed around culvert following damage from flood event

Earth fill embankment

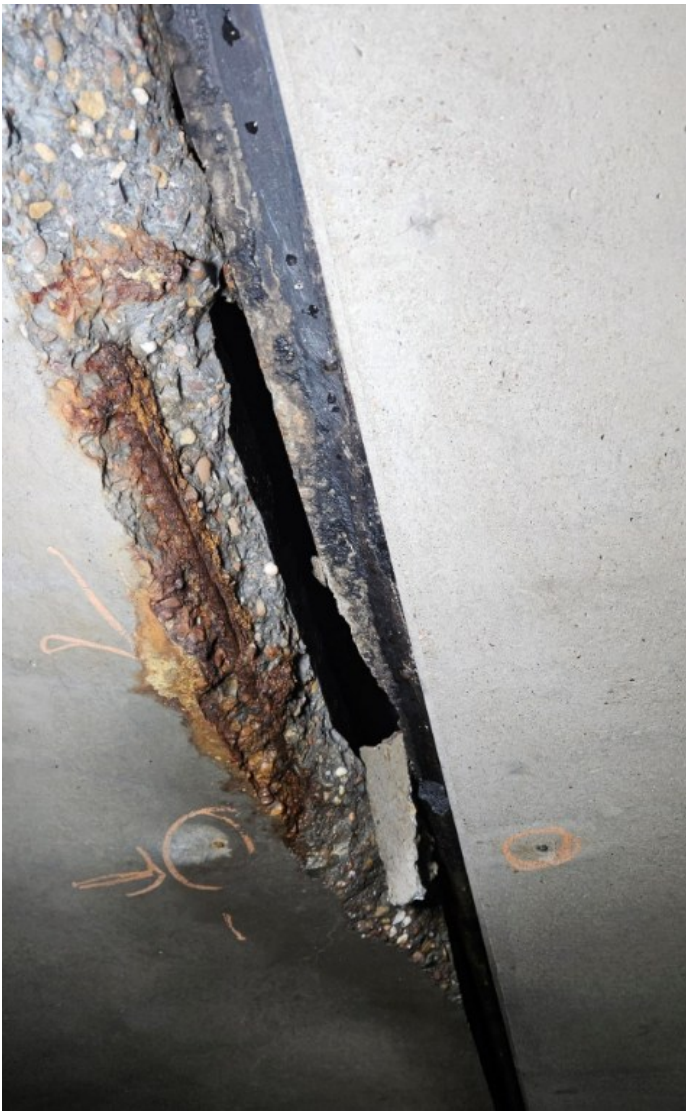
This incident was declared when, during the supervising engineer's visit, a small edge piece of a culvert joint was noticed. They pushed a camera through the hole, and exposed a large void above the culvert, initially estimated at 600mm x 3300mm x 800 mm, however the full scale of the void was unknown.

View of joint crack from within culvert

The void is located immediately downstream (approximately 2m) of the hydrobrake outfall. Water would have been forced upward, causing further damage to the defective culvert joint (previous S10 report indicates presence of cracking) before water under pressure carved out the void within the clay dam that surrounds the culvert. The presence of the void and the hole into it meant that the dam was unsupported above the joint and there was a risk that the dam crest could settle and deform. Also, if left unrepaired a similar sized storage event would result in further erosion and enlargement and extent of the void.

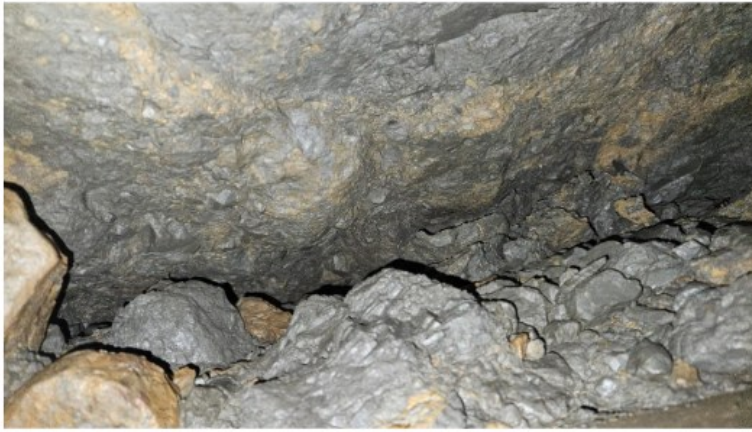
View of void above the culvert

It is most likely that the void formed during the November 2024 storage event when it was noted that the culvert from the hydrobrake was running at full bore.

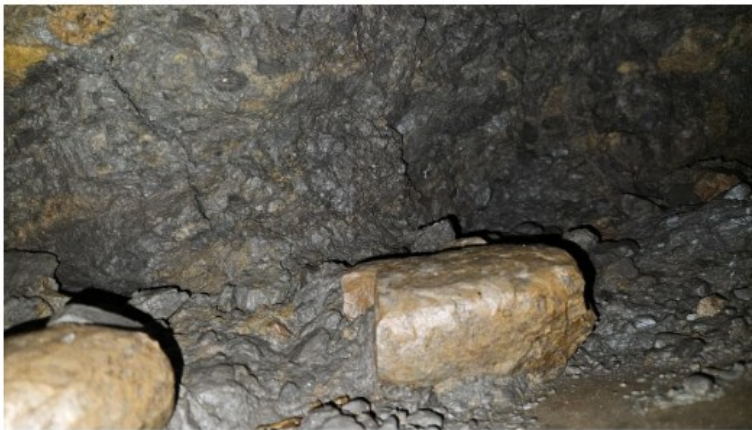
**View above culvert crown looking downstream**

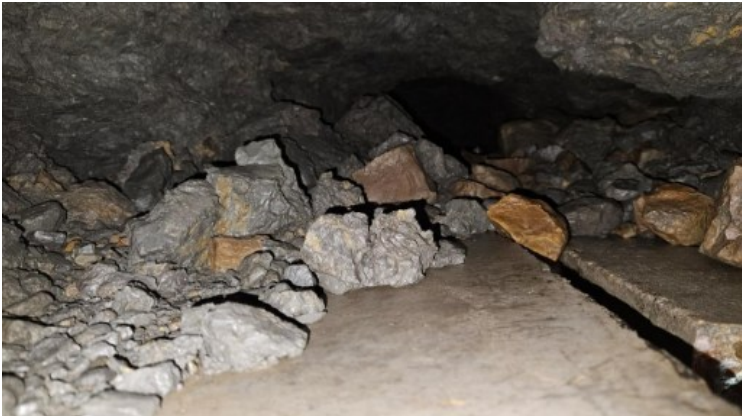
**View above culvert crown looking downstream**

View of void above the culvert

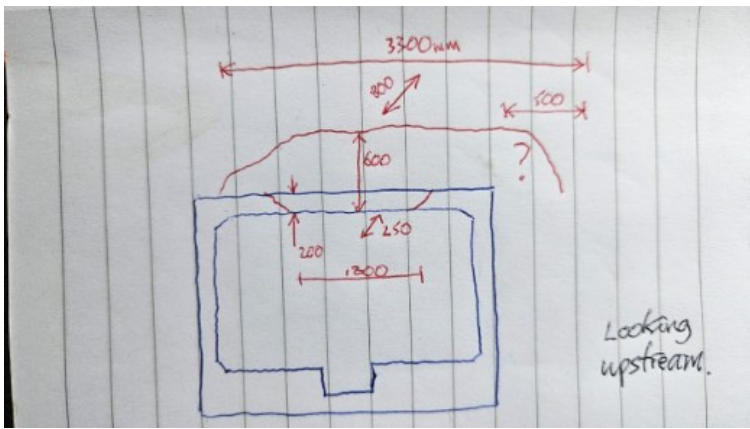
Hand sketch of void from initial investigation
