Unpermitted excavation on a flood storage reservoir

Case ID#

3268

England Regulator Reference No. 537 **Legal Status** Statutory **Reservoir Type** Impounding **Reservoir Capacity** 10 - 24,999m3 **Year of Construction** 1970 - 1989 **Main Construction Type** Earth fill embankment **Dam Height** 0 - 1.99 metres **Dam Flood Category** В **Hazard Class** High-risk reservoir Reservoir Use • Flood risk management

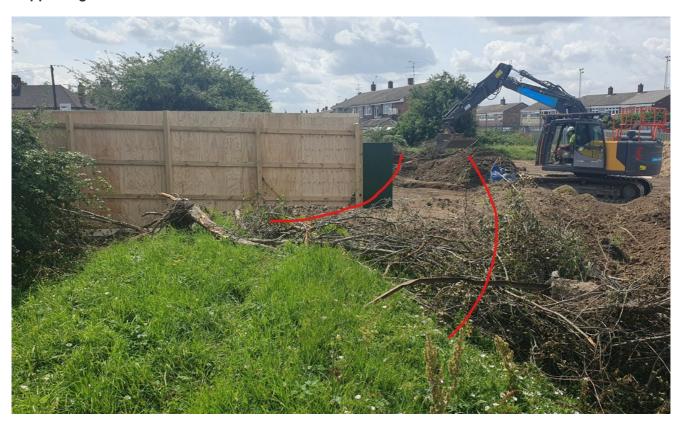
During routine maintenance works, the undertaker of a flood storage reservoir noticed that someone had excavated into the dam. A contractor working on behalf of a developer had removed a section of the bank. The undertaker notified the supervising engineer and investigated the cause. The undertaker and supervising engineer visited the contractor within 24 hours. They instructed them to stop all works and reconstruct the embankment. The reconstruction was completed under supervision of the supervising engineer. The available documents on the Local Planning Authority website did not make it clear what the exact approved details for works on the dam were. The Environment Agency had been formally consulted, and they had provided details of their required conditions. Work on site suggested the contractor was not aware of the required conditions. The situation appears to have occurred by a lack of suitable communication. The undertakers have since discussed with the planning authority: how the incident was able to occur what corrective actions should be taken measures to prevent a reoccurrence.

Rapid attendance of undertaker and SE to construction site and instruction to cease works, and reinstate bank.

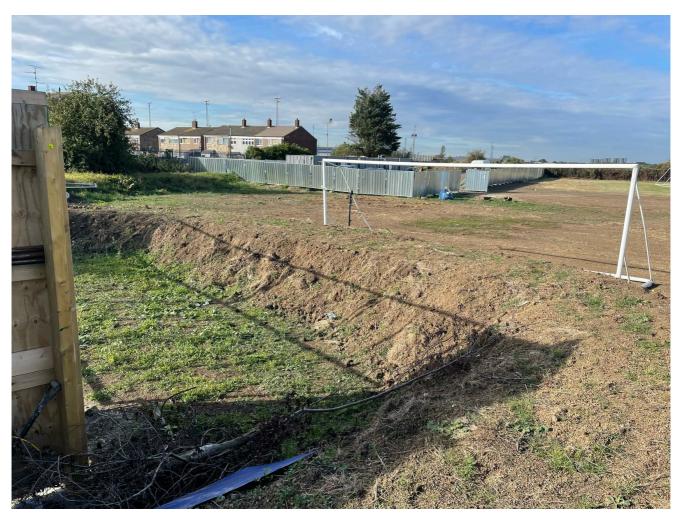
Impacts on the Reservoir

External erosion
